## *Repairing a Hollow Molded Supra's Wing*

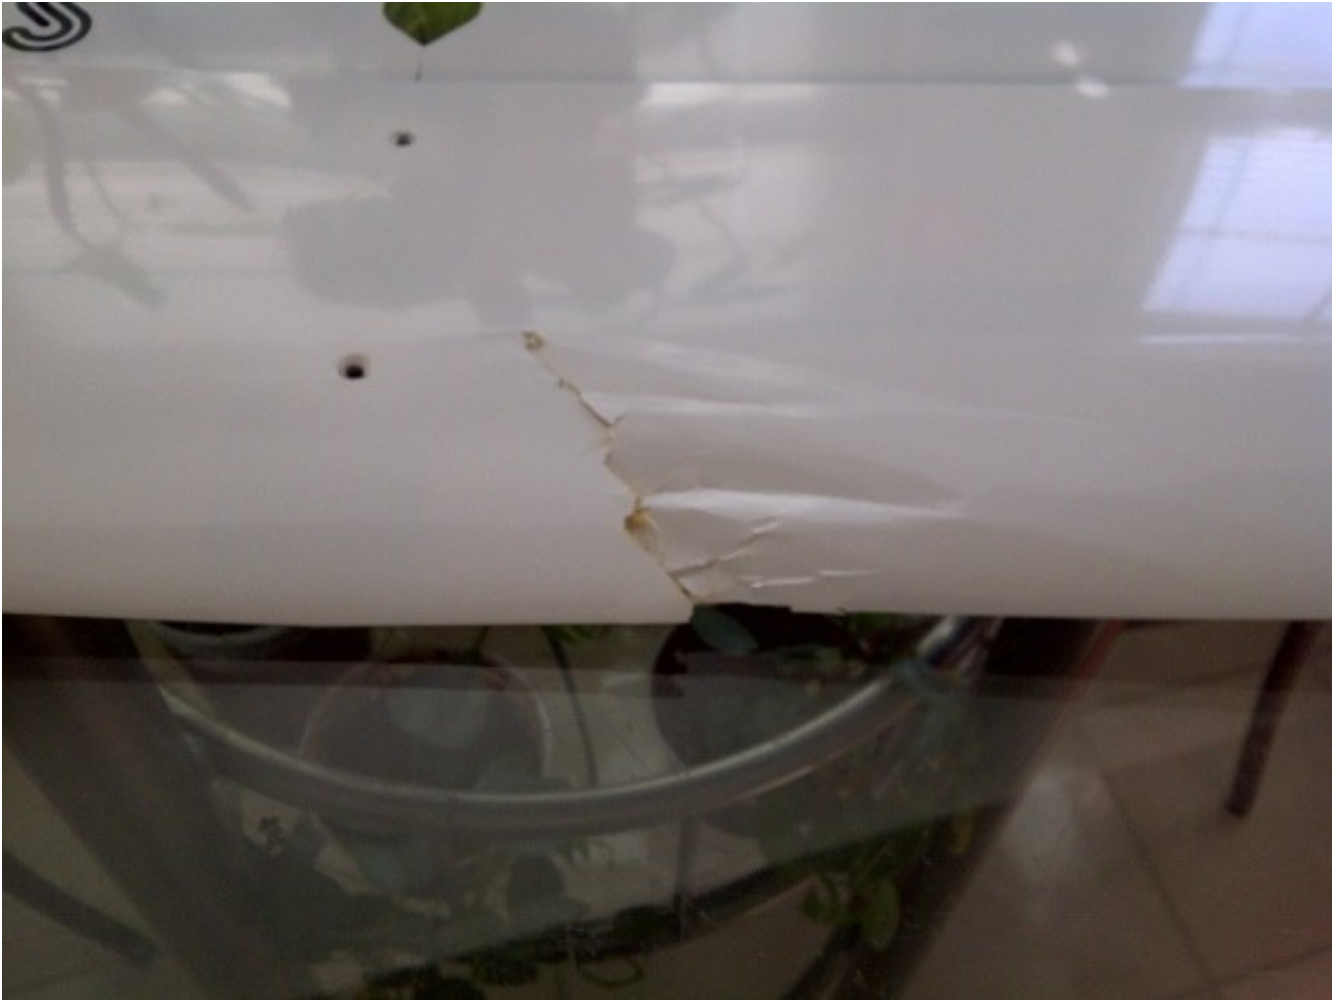
*Stopped by the spar*

Some part of the other sailplane in the accident was hard enough to crush the leading edge of Bob's wing back as far as the spar. So the damage to the wing was spread out from the point of impact, because the wing's leading edge was crushed back and folded in on itself like an accordion for the length of about a foot on the bottom and only seven or eight inches on the top; not insubstantial.

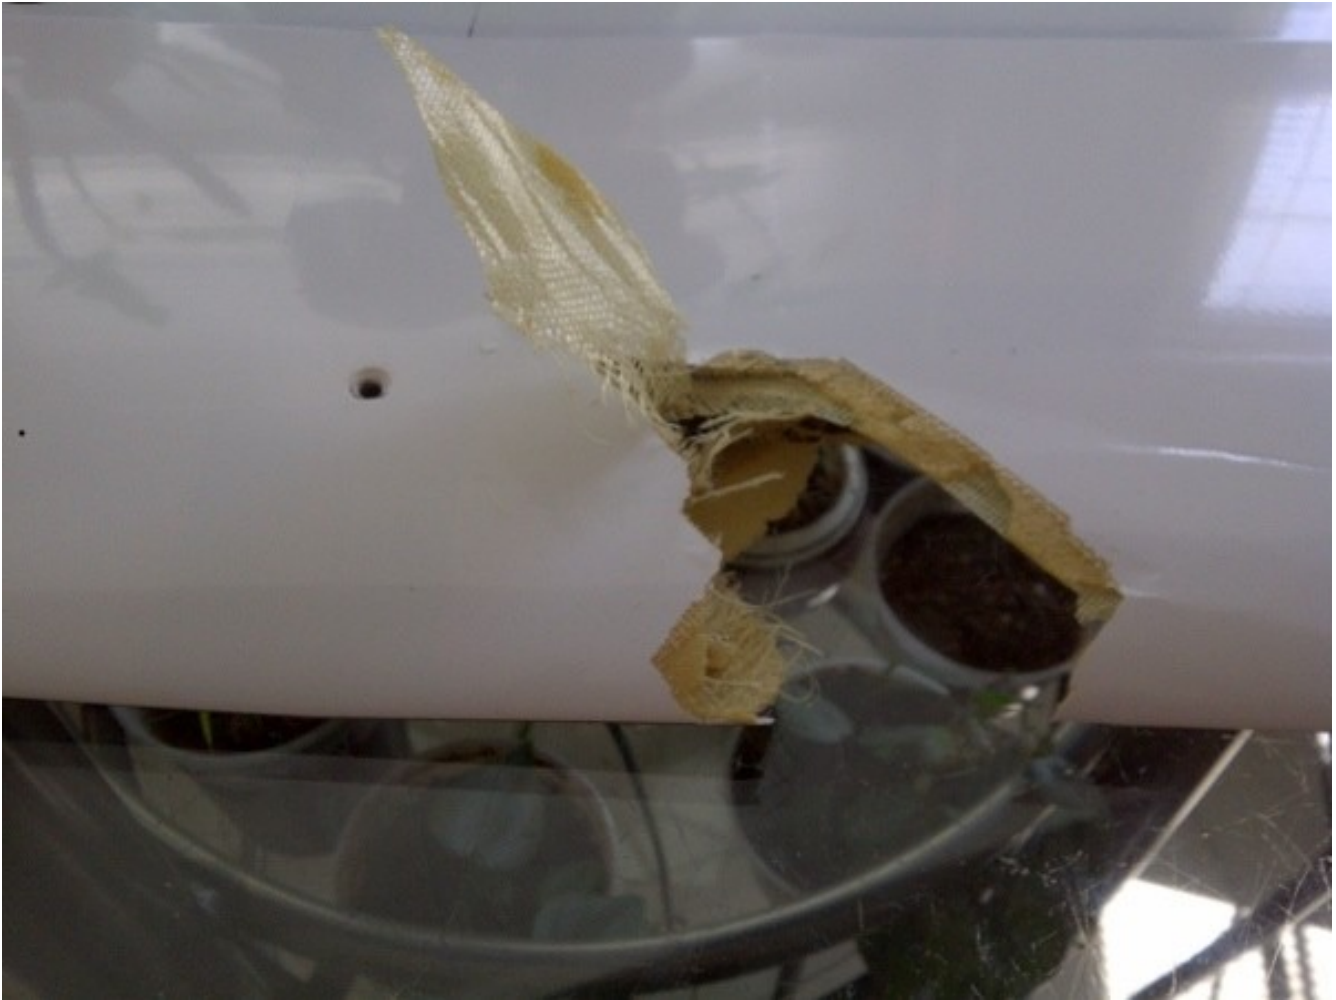
*Removing damaged material. Look closely and you can see how coarse the Kevlar netting is and the creases in the wing.*

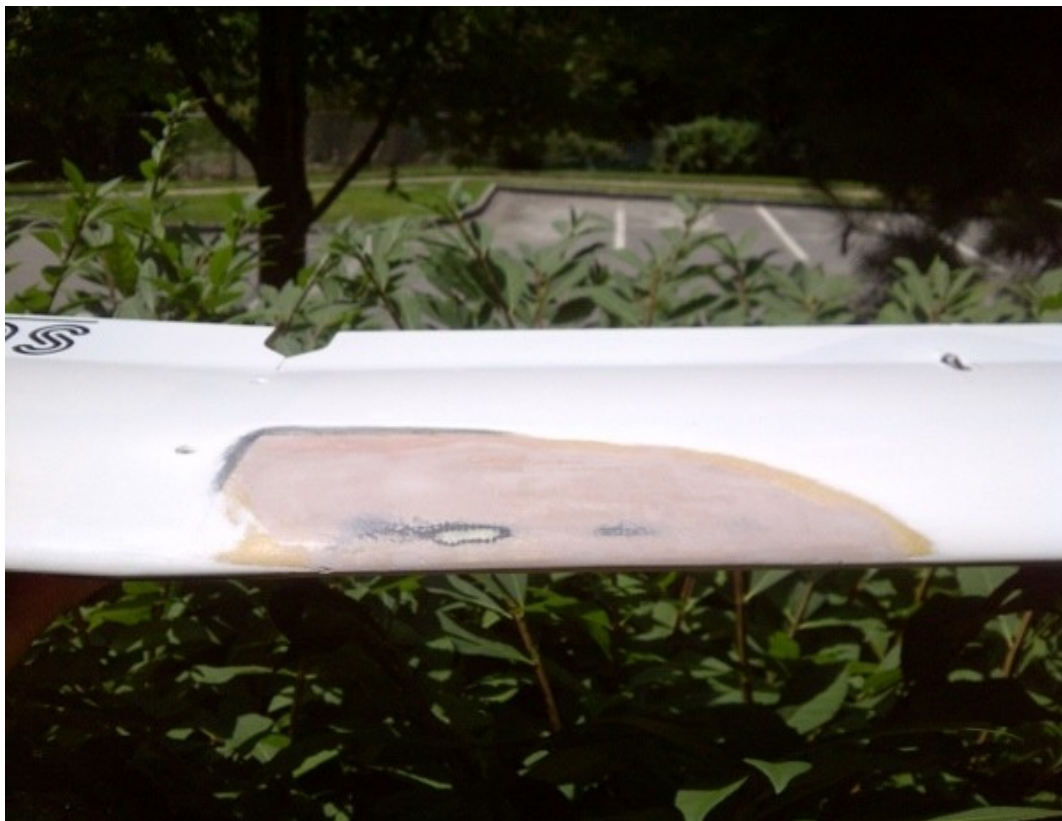
*Sanded between applications of thin layers of Bondo. Yup, the carbon fiber layer was a tad high in one spot of the D-channel, but not anymore. It's okay; it has fiberglass underneath. The black edge in the rear of the repair is where the paint was feathered down to the carbon cap on the spar.*

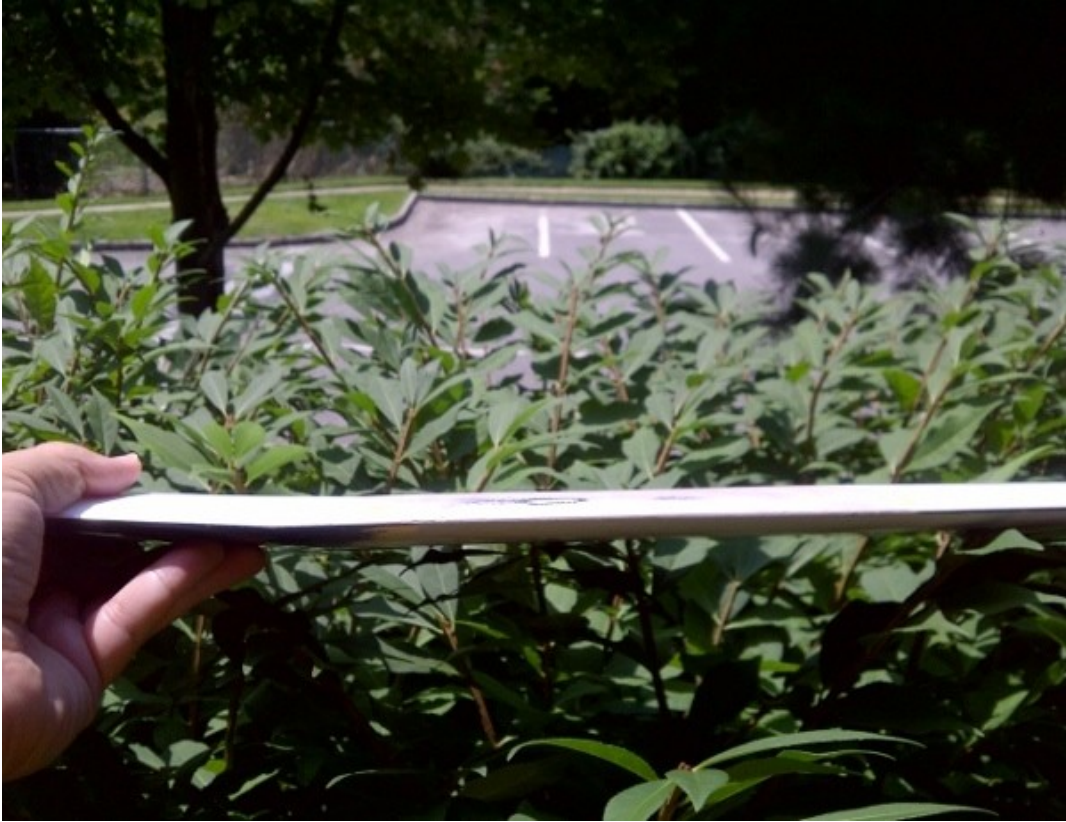
*A straight leading edge, for a given value of straight. In this case a ruler was used.*
