## *Repairing a Hollow Molded Supra's Wing*

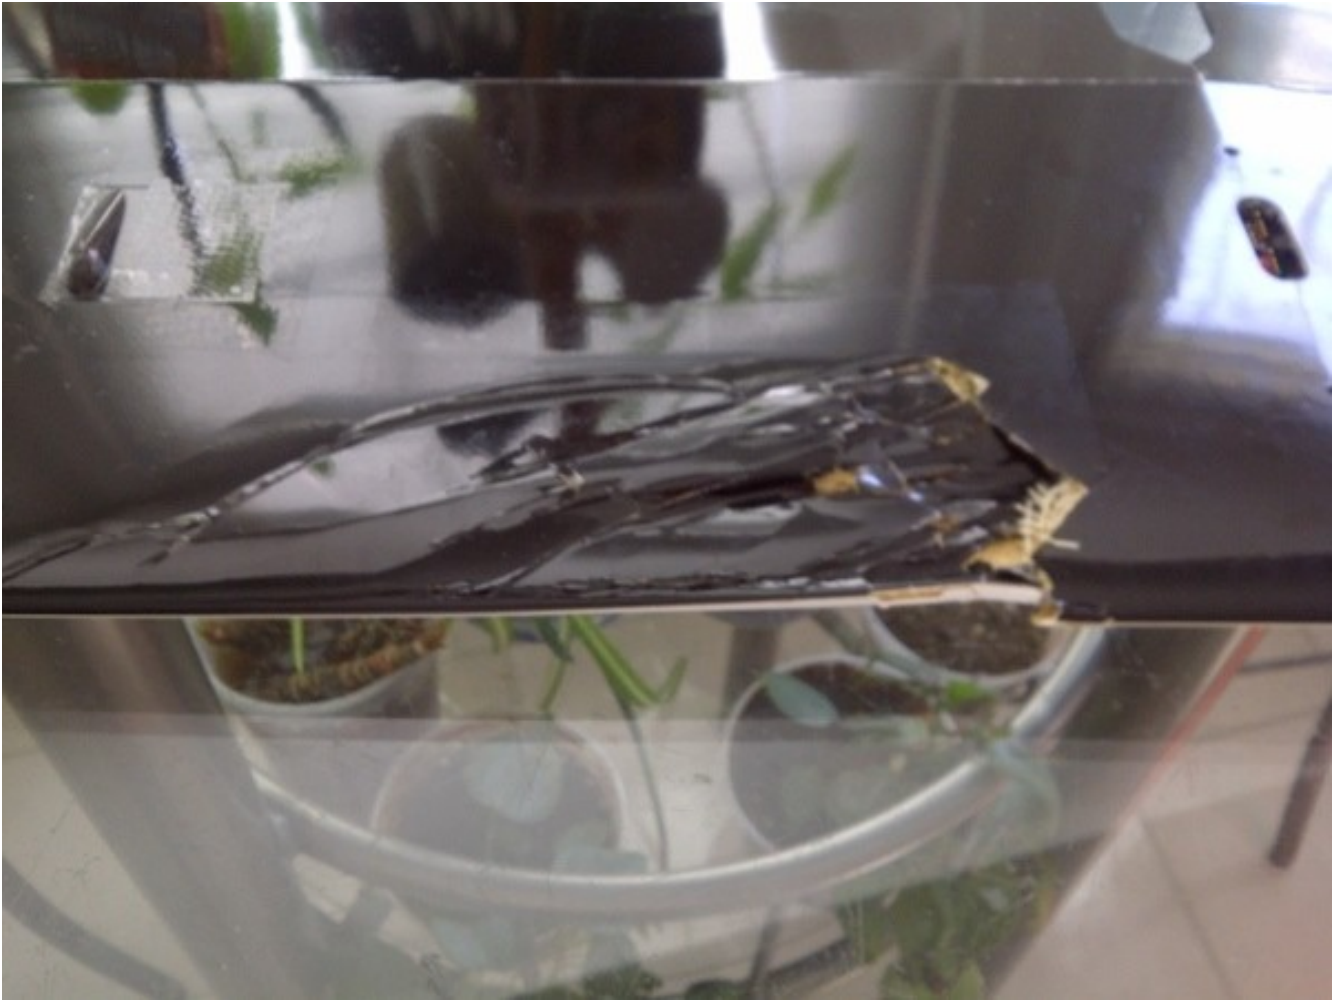
*Got your attention, didn't it?*

The damage you see in the pictures and a broken fuselage came about from two sailplanes colliding when coming in for landings near each other during the June ESL Unlimited contest.

Some part of the other sailplane in the accident was hard enough to crush the leading edge of Bob's wing back as far as the spar. So the damage to the wing was spread out from the point of impact, because the wing's leading edge was crushed back and folded in on itself like an accordion for the length of about a foot on the bottom and only seven or eight inches on the top; not insubstantial.

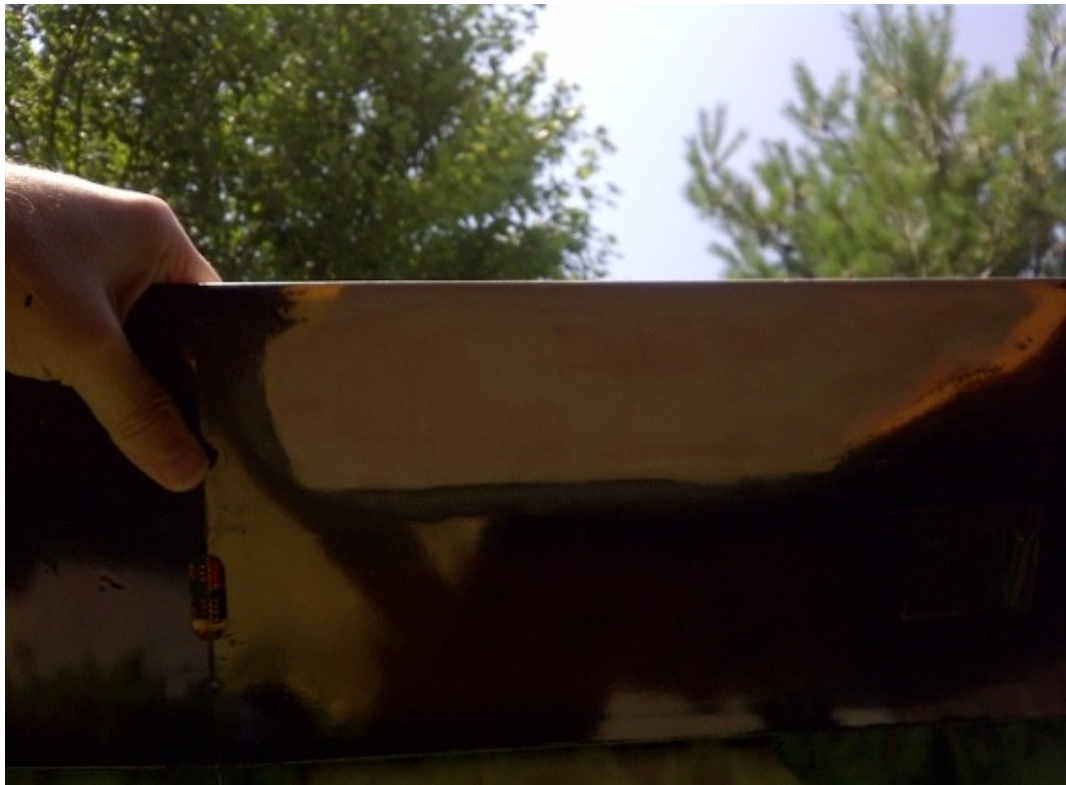
*One of those rare instances in life where bigger isn't necessarily better.*

The repair itself blends well with the wing's airfoil. What seems like long straight lines at first glance is really a bunch of complex curves, especially near the wing root. Also the thickness of the wing isn't constant, further complicating the task of blending everything together. The solution: sand, measure, repeat, repeat, repeat.

The damaged center wing weighed 23 ounces. Damaged material weighing 0.25 ounces was removed from it, bringing its weight down to 22.75 ounces. After repairing the damaged section the wing weighed 24.6 ounces. Fortunately, the repair was near the center of the wing, so adding 0.23 ounces near the joiner on the opposite end of the wing balanced the center wing laterally and brought the overall weight to 24.83 ounces. Considering that the repair on the bottom of the wing is a foot long and the top is seven or eight inches, that seems reasonable to me.
